小島 **BIRD FREE**

Report on application of 小島 *Bird Free*  
to the east side of Preston's Road flyover, 21 July 2015

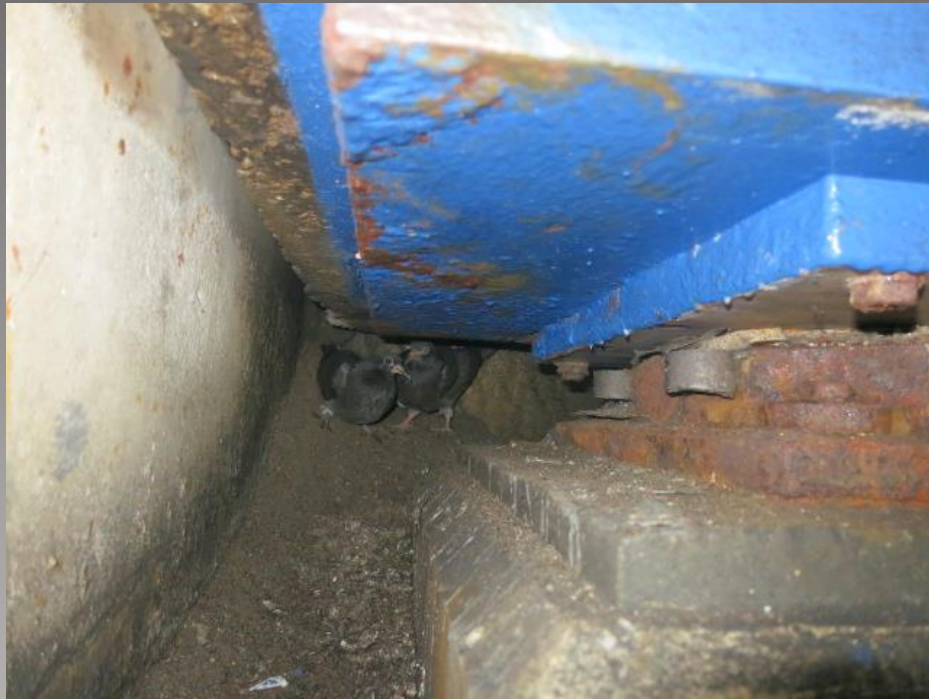
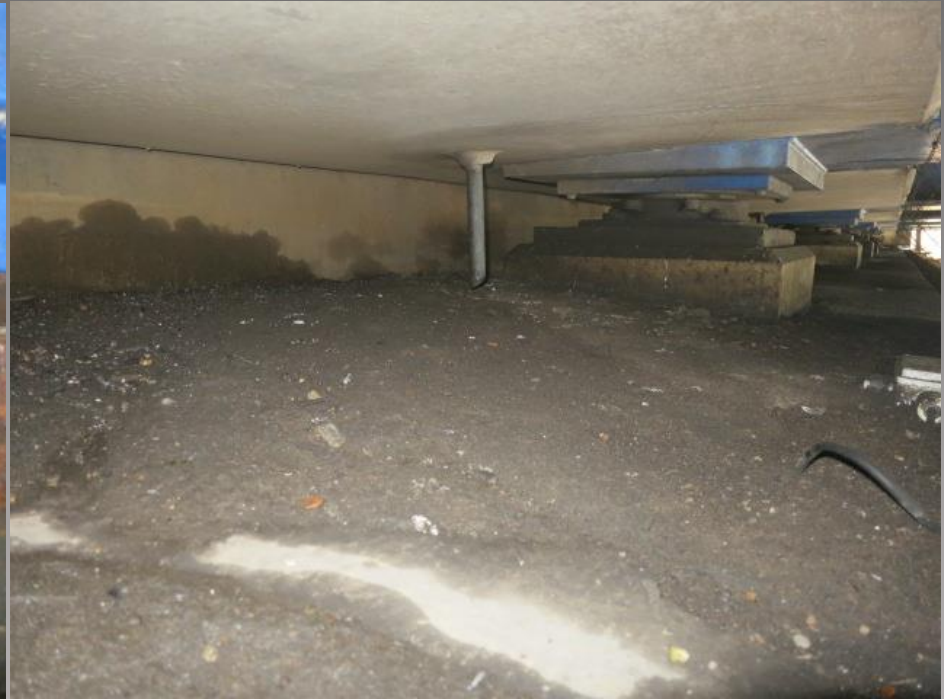
Pigeons had been nesting at the back of the bearing shelf in the corners (above left). The entire bearing shelf was covered in faeces.

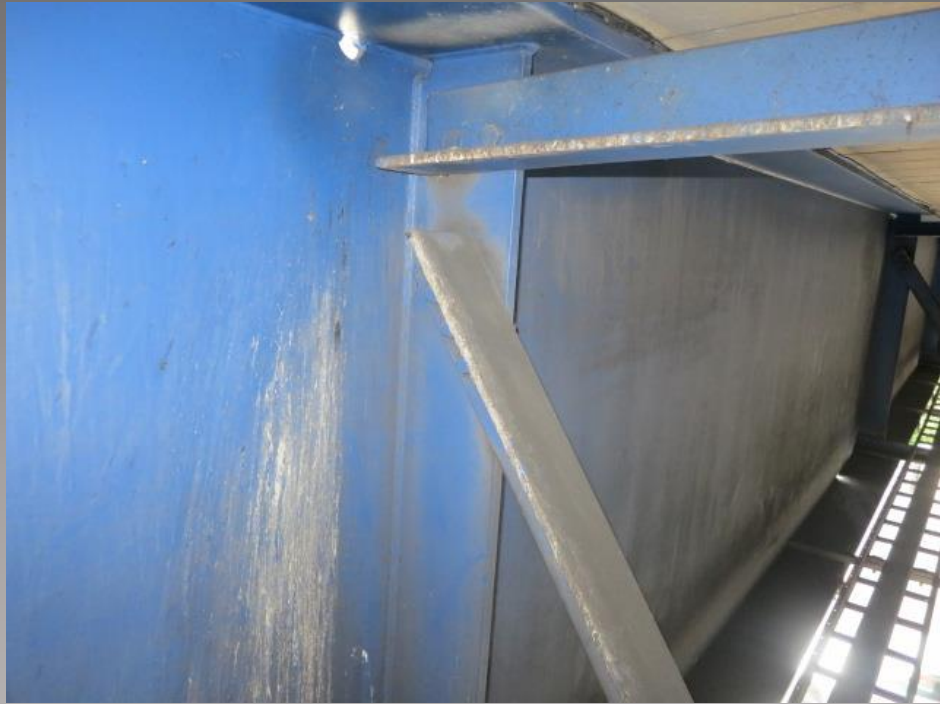
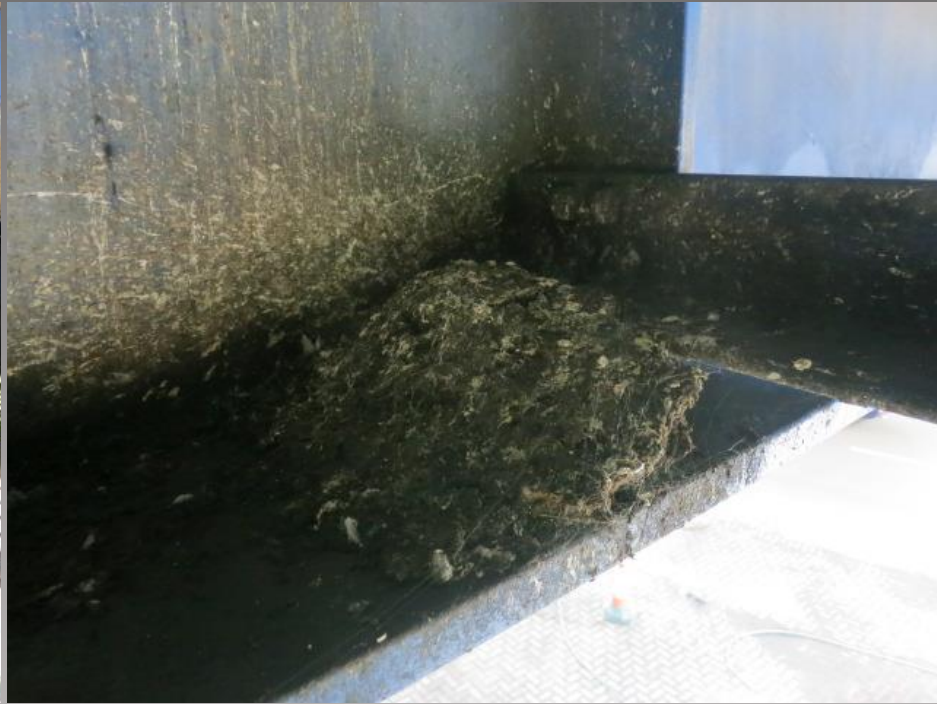
The upper flanges of the cross members (above left) were favoured night roosts. This was evident from the accumulation of faeces on the flanges below (above right).
